KNKT.08.10.23.04

Aircraft Accident Investigation Report

PT. ASI Pudjiastuti (Susi Air)

PK – VVL

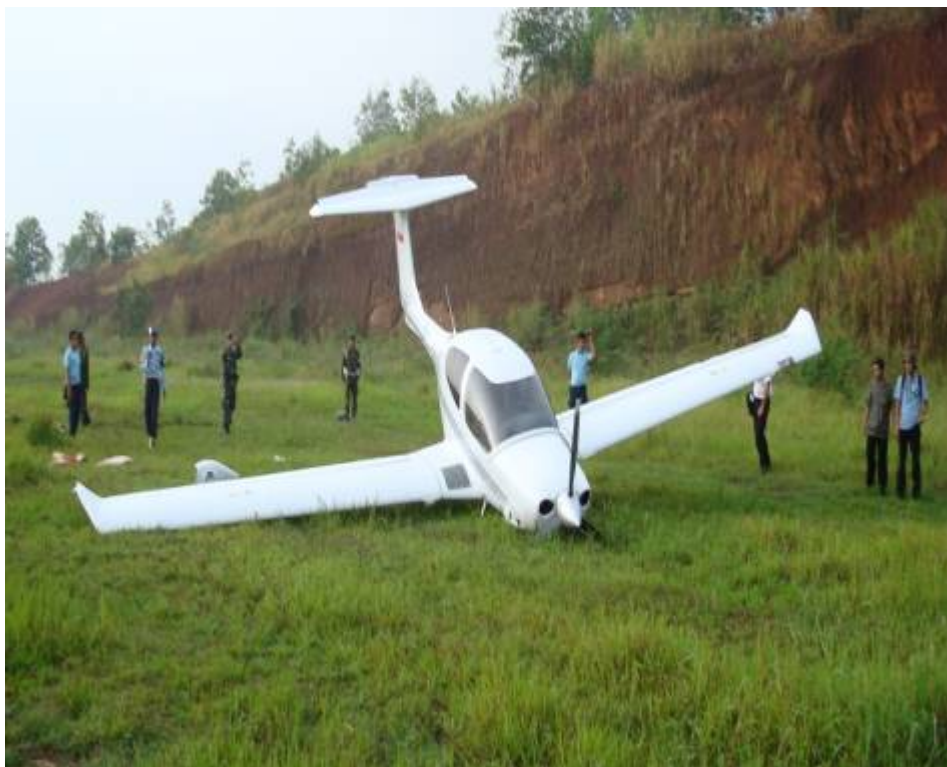
The aircraft was substantially damaged. The nose and right main landing gear were fractured and the propeller blades were bent.

Figure 1: The aircraft safely landed at the Infantry Training Center shooting range, Cipatat, Padalarang

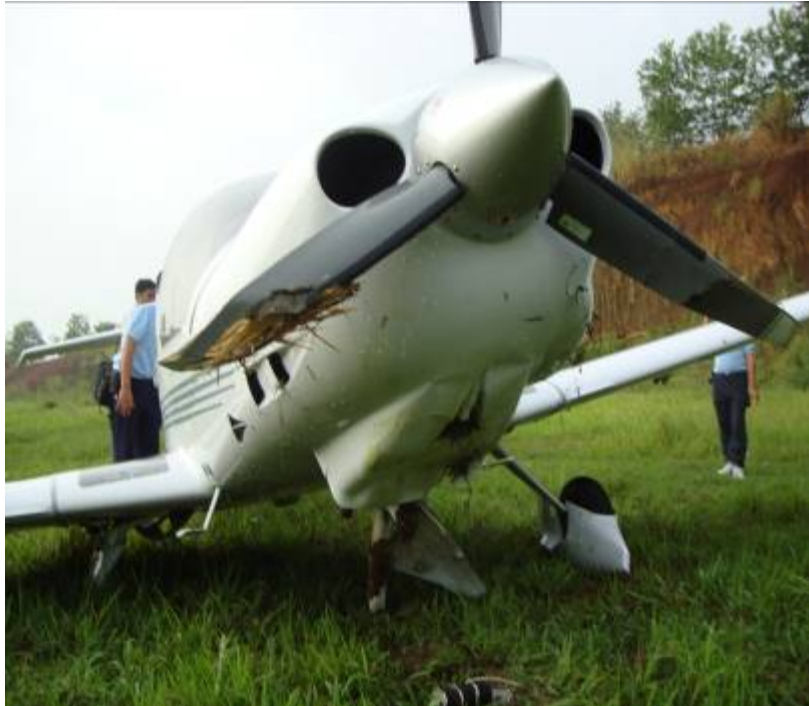
During the forced landing at the military shooting range at Cipatat Padalarang, West Java, the touchdown and initial ground roll were reported to have been smooth. However, due to the rough ground surface, the nose and right main landing gear were torn from the aircraft and the propeller blades were bent and fractured as they struck the ground.

Figure 3: Damaged nose and right main landing gear, and propeller blades

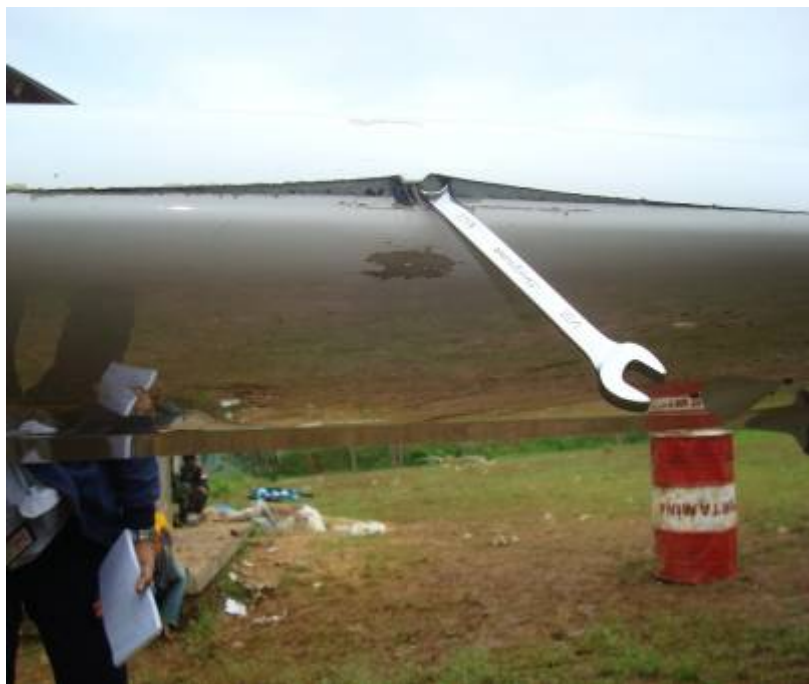
Figure 4: Right wing leading edge split in 2 locations

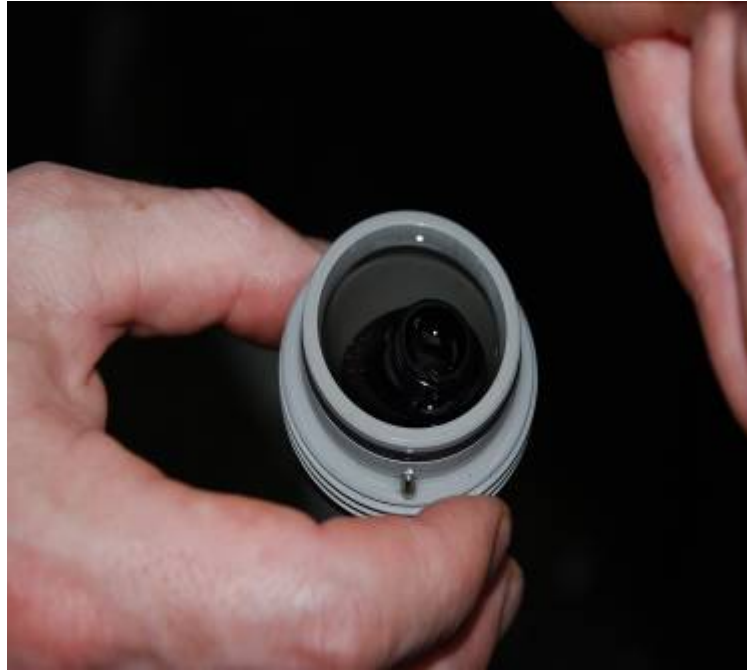
1. The fuel system filters were clean. No dirt or particles were found.

Figure 5: Fuel filter found clean condition

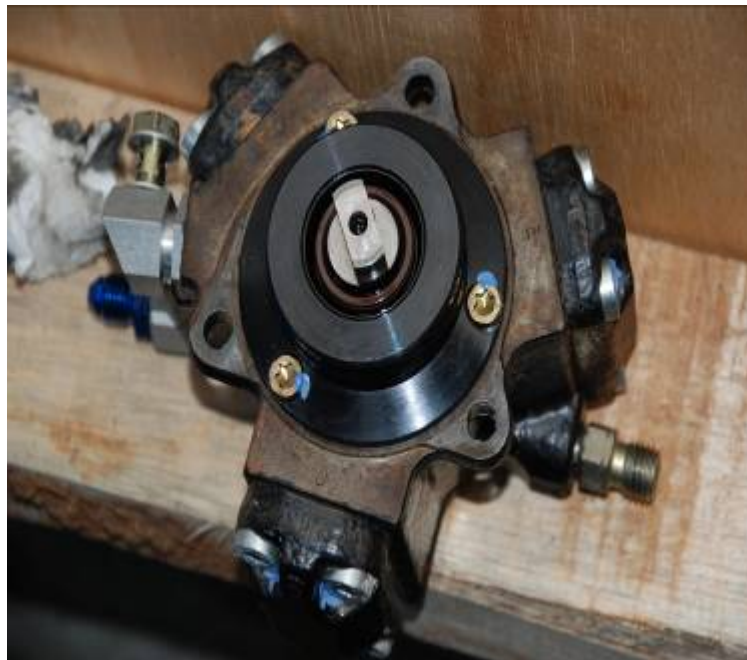
Figure 6: High Pressure Fuel Pump

2. There was no fuel in the fuel line between the Low Pressure Fuel Pump (Feed Pump) and High Pressure Fuel Pump (HPFP). It was dry.

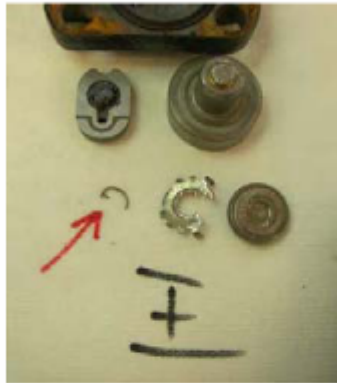
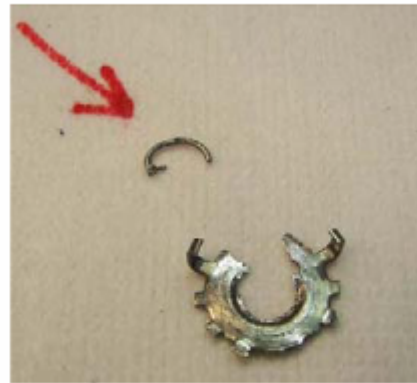
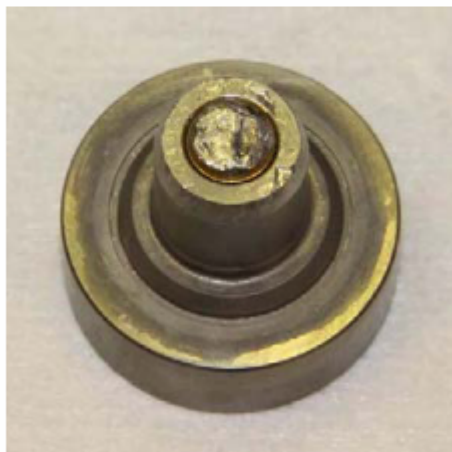
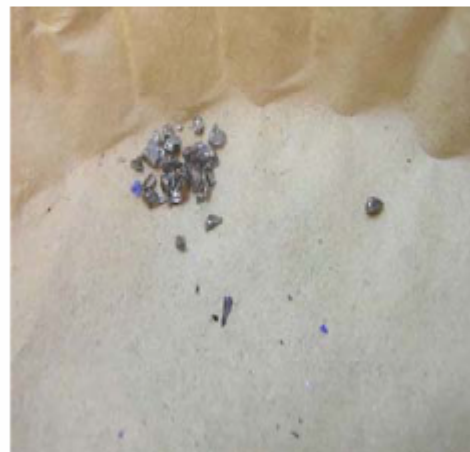
Figure 8: High Pressure Fuel Pump chamber E damaged

The piston of chamber E failed at its upper side. Due to the continued turning of the engine driven fuel pump there are hammered pattern on the fracture surface. The valve cage and the lock ring of this chamber are destroyed.

The High Pressure Fuel Pump was contaminated by debris from its failed valve cage and lock ring.

It is likely that the High Pressure Fuel Pump was contaminated by debris from its failed valve cage and lock ring.

The National Transportation Safety Committee recommends that the Directorate General of Civil Aviation request the European Aviation Safety Agency to ensure that the engine manufacturer, Thielert Aircraft Engine GmbH, conducts an assessment of this High Pressure Fuel Pump failure and ensure that appropriate safety action, by the manufacturer, is taken to prevent a similar occurrence with this engine type.

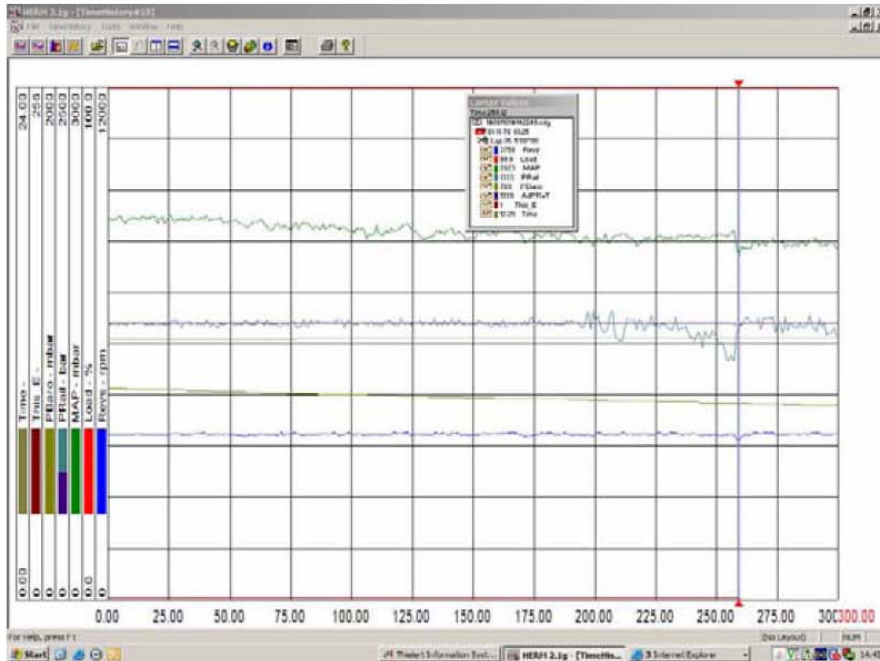
Pic. 17: Lap 35, rail pressure starts to fluctuate and decreases, FADEC switches to ECU-B due to low rail pressure

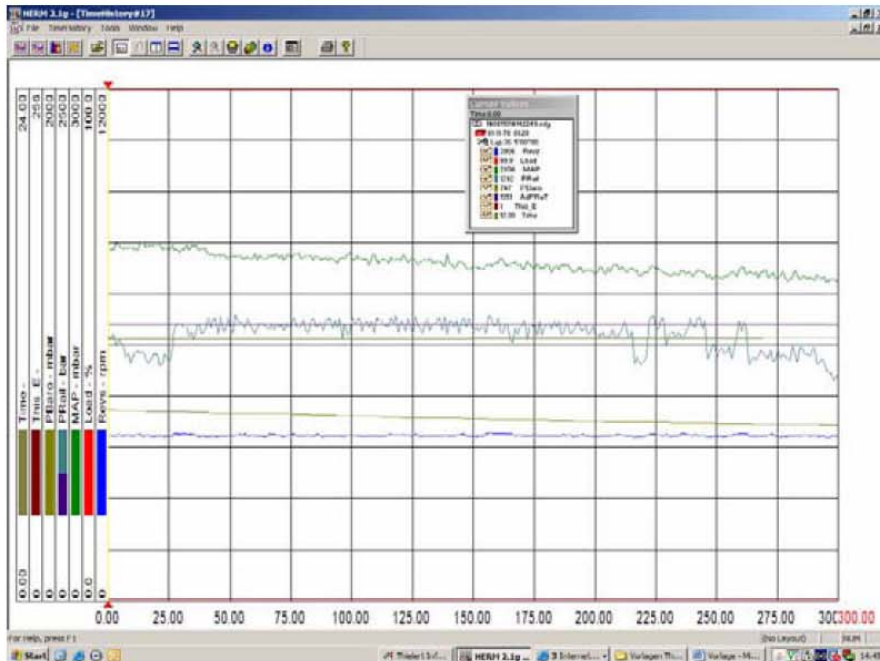
Pic. 18: Lap 36, engine running on ECU-B, problems with rail pressure gets worse

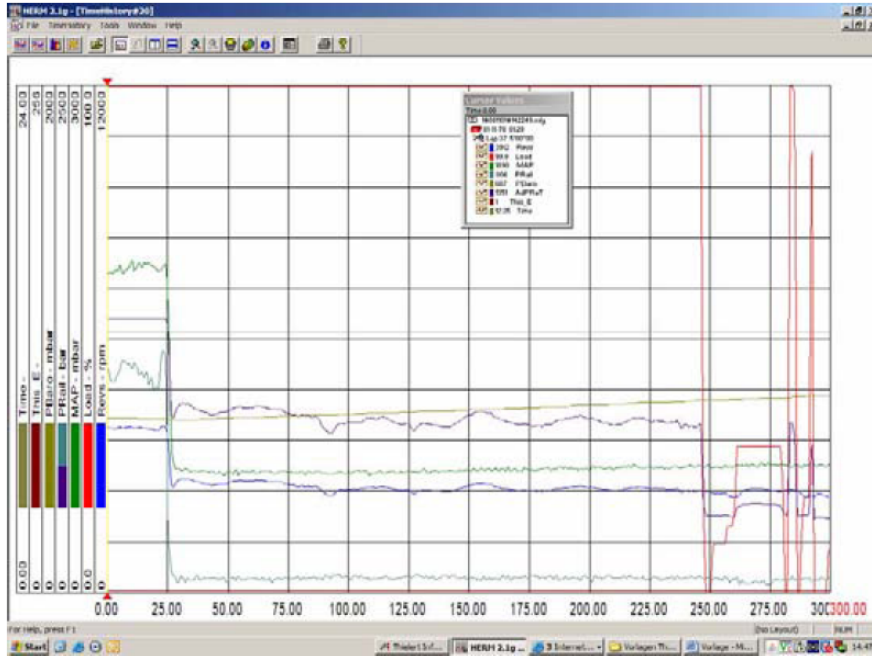
Pic. 19: Lap 37, lack of rail pressure causes engine to quit

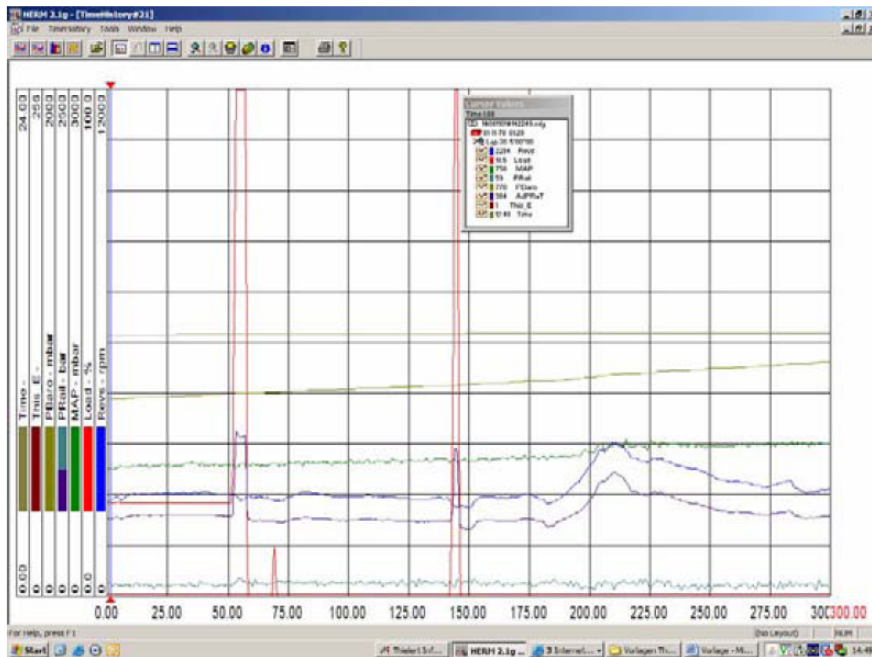
Pic. 20: Lap 38, restart in flight not possible

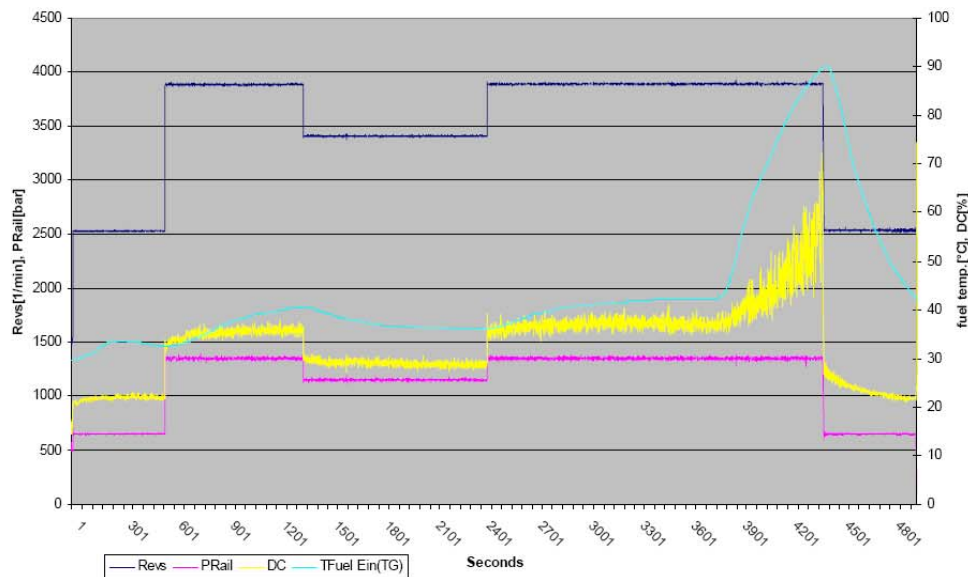
Pic. 23: Acceptance Bench test of the affected High Pressure Pump at the time of production

At the time of production the High Pressure Pump with the serial number 11531 was well above the limits of 1350 bar at a fuel temperature of 70°C, which is one of the acceptance criterion of new High Pressure Pump.

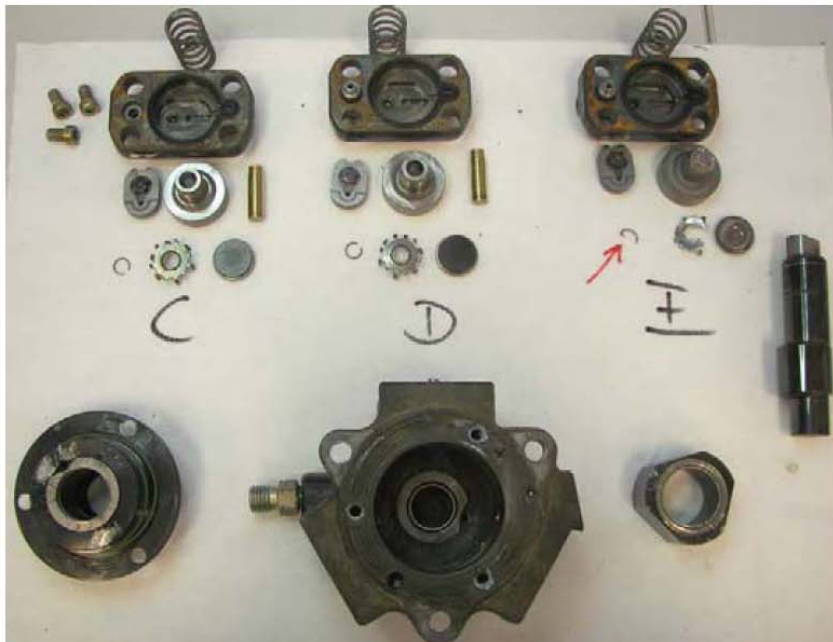
Pic. 25: Teardown, chamber E shows damages

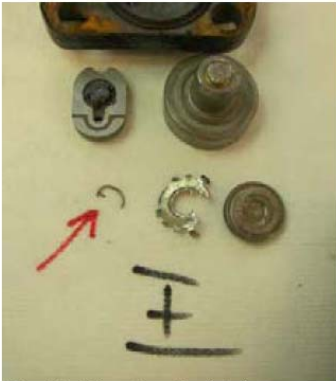
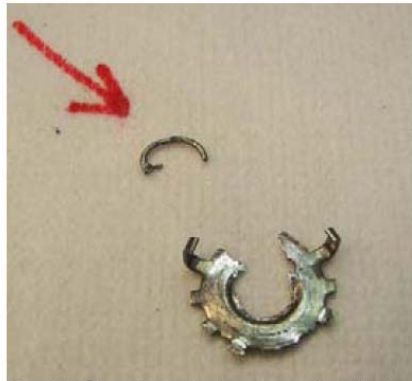
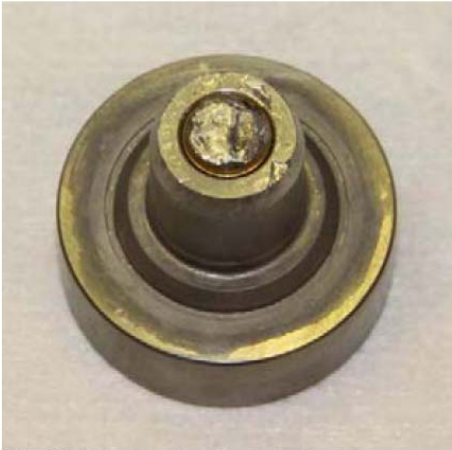
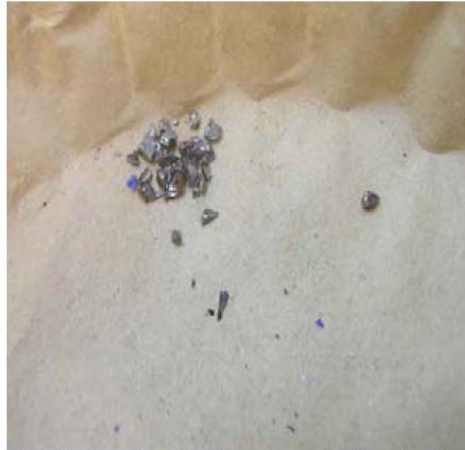
Pic. 26: Chamber E, details

Pic. 27: Chamber E, valve cage & lock ring

Pic. 28: Chamber E, cylinder incl. piston

Pic. 29: Chamber E, debris found in chamber E

The piston of chamber E failed at its upper side. Due to the continued turning of the engine driven fuel pump there are hammered pattern on the fracture surface. The valve cage and the lock ring of this chamber are destroyed.

The failure is limited to one cylinder of the high pressure pump. The failure of the chamber E and the debris found explain the damage to all remaining parts of the high pressure pump. The degree of destruction shows that the time during which the pump run with a failed chamber seems to be low.

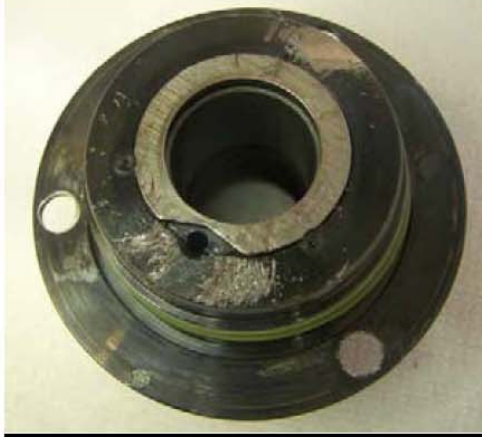
Pic. 30: Radial and axial bearing

The bearing bush does not show any wear or tear. There are significant scratches and hammer marks visible on the axial bearing surface.

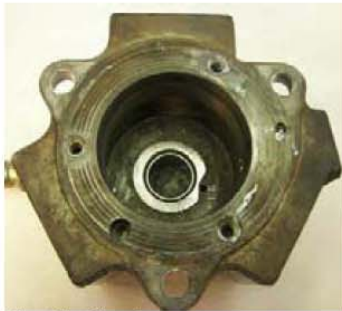
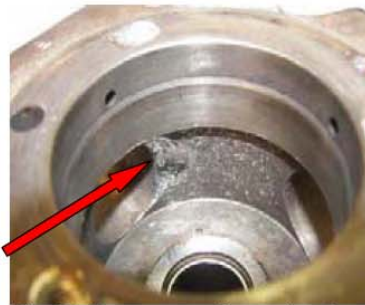
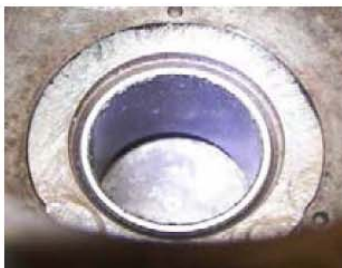
Pic. 32: Damage marks at chamber E

The housing shows several damage marks especially in the area of chamber E.

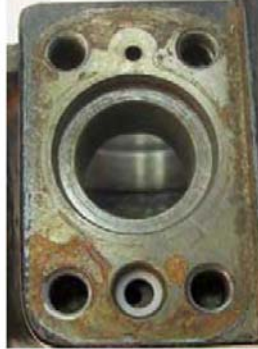
Pic. 34: inlet chamber D

The inlets show slight corrosion but only limited to the outer surface which have contact to the environment. All internal surfaces show no signs of corrosion or damages.

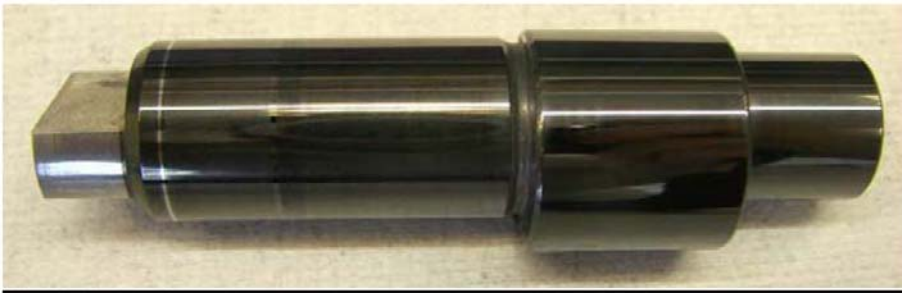
Pic. 36: Camshaft

The camshaft does not show any signs of damage or corrosion

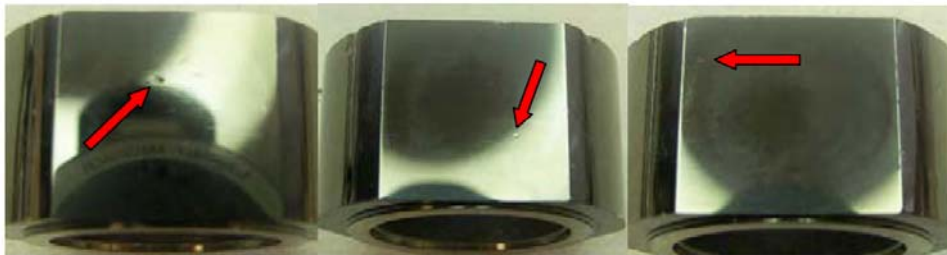
Pic. 38: Polygon surface C

The bearing bush of the polygon shows one deeper scratch in the coating of the bearing. On the outer surfaces of the polygon there are hammer marks visible. These marks were potentially caused by the debris found in the pump, see pic 29.

Although the surfaces show hammer marks there are still in a proper condition.

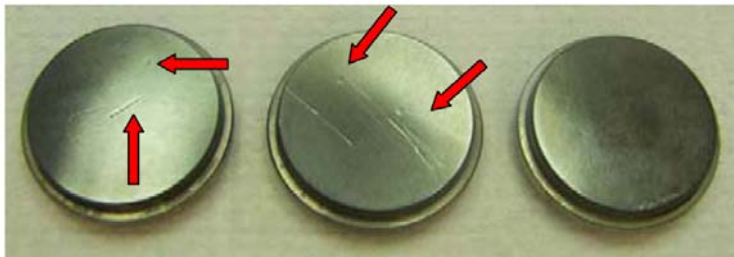
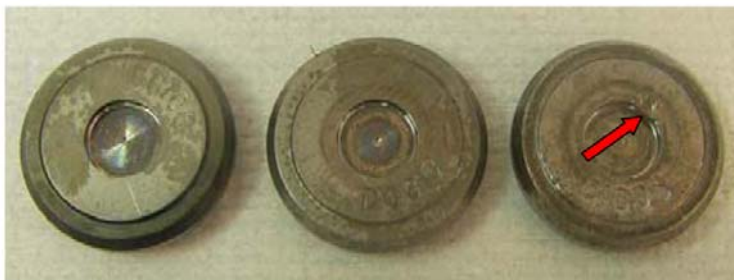
All tappets show on the polygon side some deep scratches and hammer marks in their coating. The piston sides of all tappets are in good conditions. Only the tappet of chamber E shows a single hammer mark.

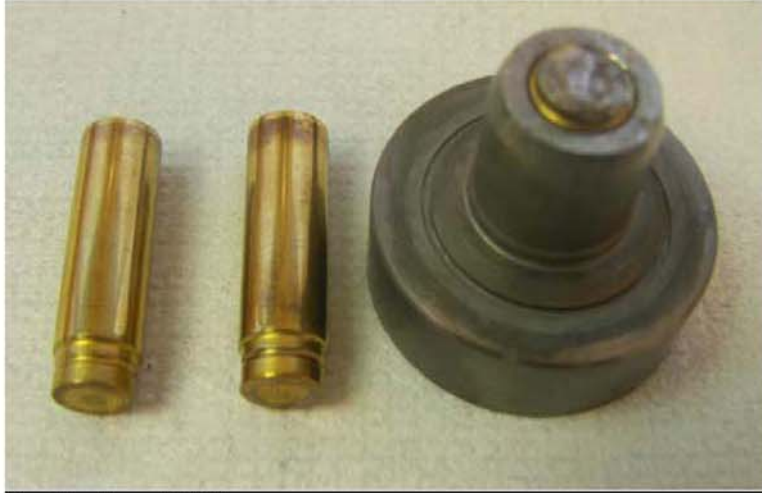
Pic. 41: pistons (C/D/E)

On the surface of piston C there is a small hammer mark visible. Piston C and piston D show blue and brown heat colors. Both pistons show nearly no damages at all. Piston E could not be removed from its cylinder chamber by normal manual forces.

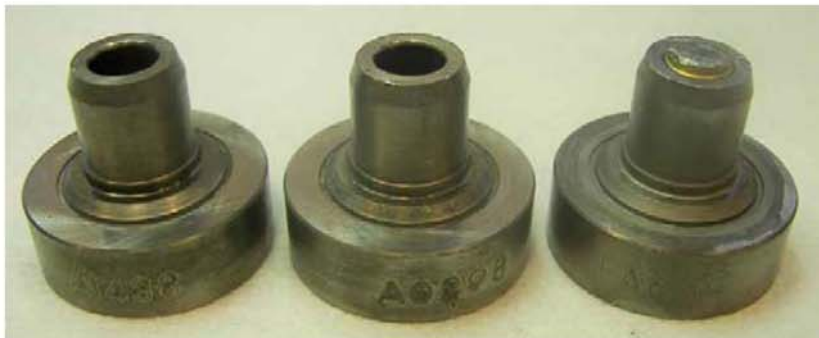
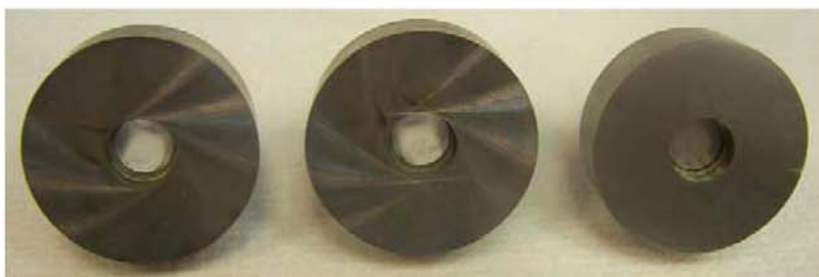
The cylinder bores of cylinder C and D just show minor wear and tear. All sealing surfaces are in a proper condition. The cylinder bore E is blocked by the piston. The sealing surfaces are in proper condition as well.

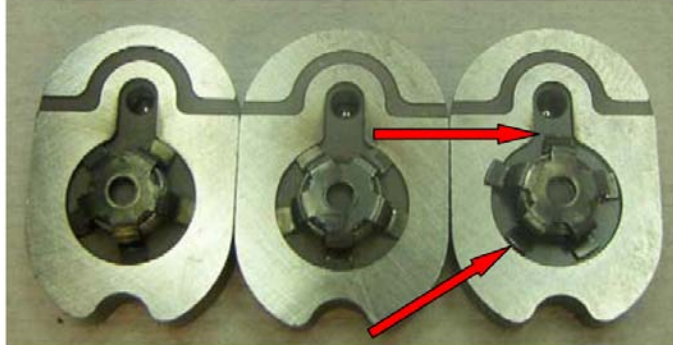
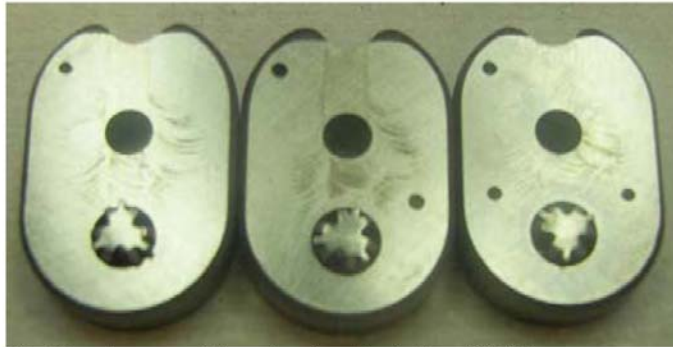
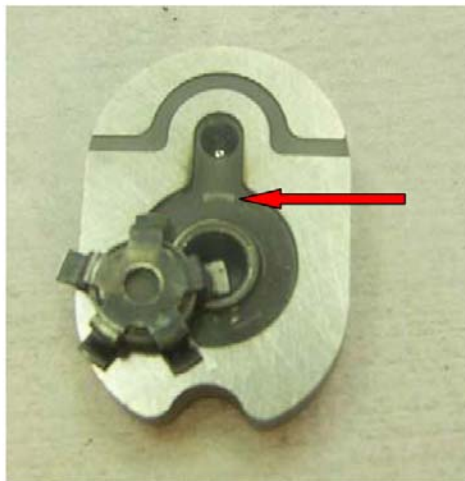
There are no damages or signs of wear and tear at the valve assemblies C and D. There are scuffing marks at the valve assembly of chamber E. It seems that the valve cage has moved.

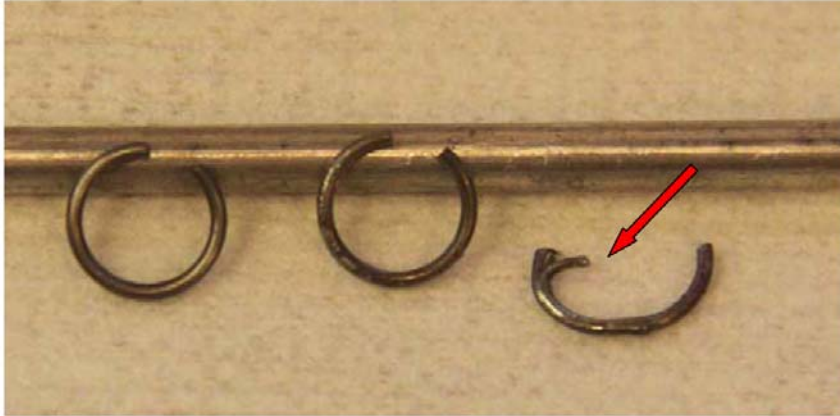
Pic. 47: lock rings (C/D/E)

The lock rings of the pistons C and D have minor deformation marks originating from piston movement, which is normal. The lock ring of piston E is significantly deformed.

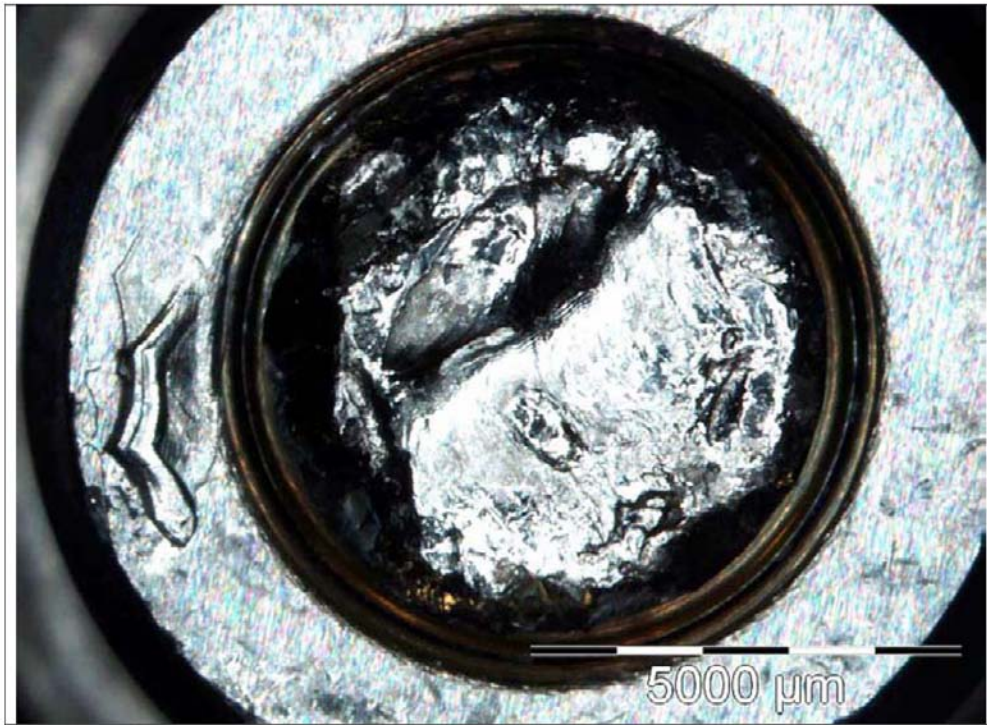
The piston of chamber E is broken at the mounting for the tappet disc. The fracture surface is badly damaged, which might have been caused after the piston failed and when the pump was in operation. Only fragments of the counterpart, which caused damage on several parts of the pump, are left. The piston was found stuck in the cylinder.

Pic. 48: Fracture surface of the piston, which is still seated inside the cylinder.

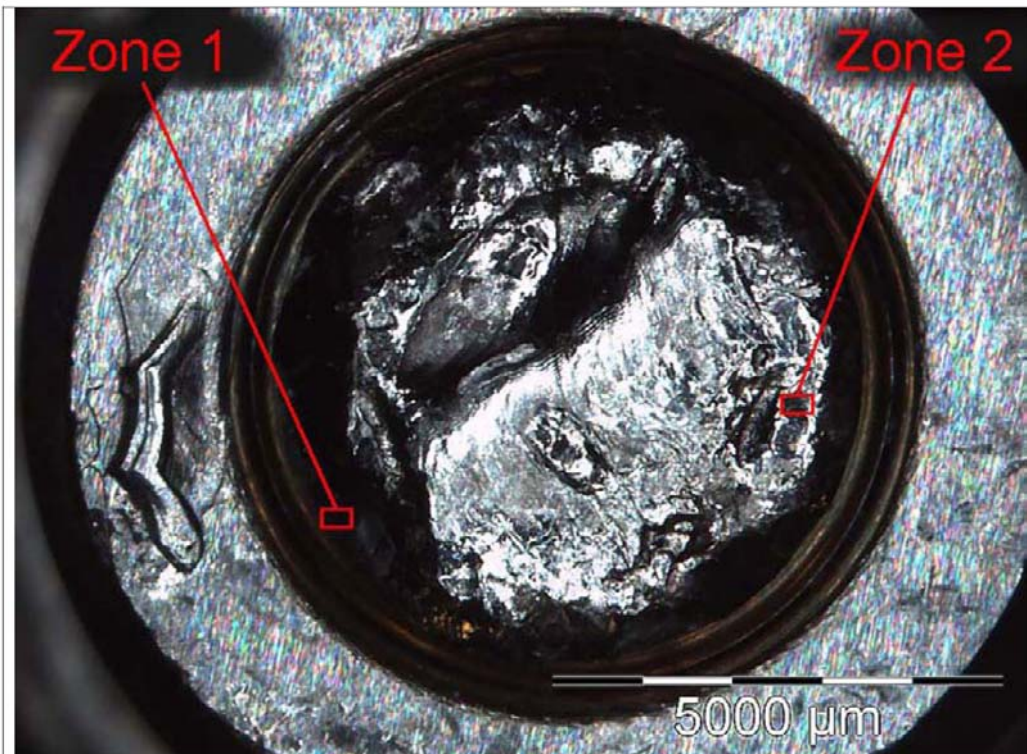
Pic. 49: Remains of the original fracture

Remains of the original fracture were found in two places. Those areas were marked with Zone 1 and Zone 2 in the figure above and are described / documented in the pictures to follow.

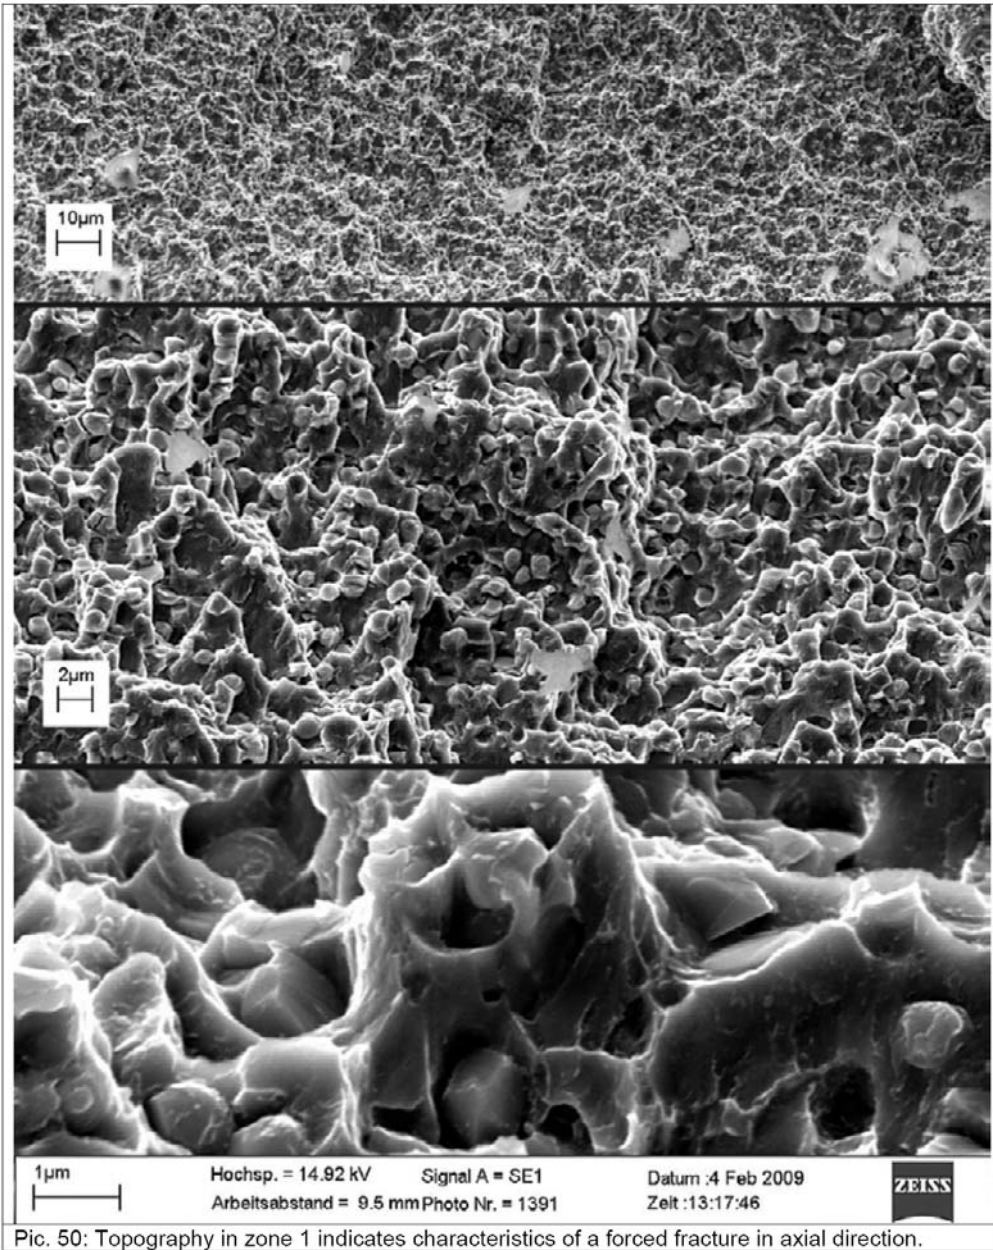
Pic. 50: Topography in zone 1 indicates characteristics of a forced fracture in axial direction.

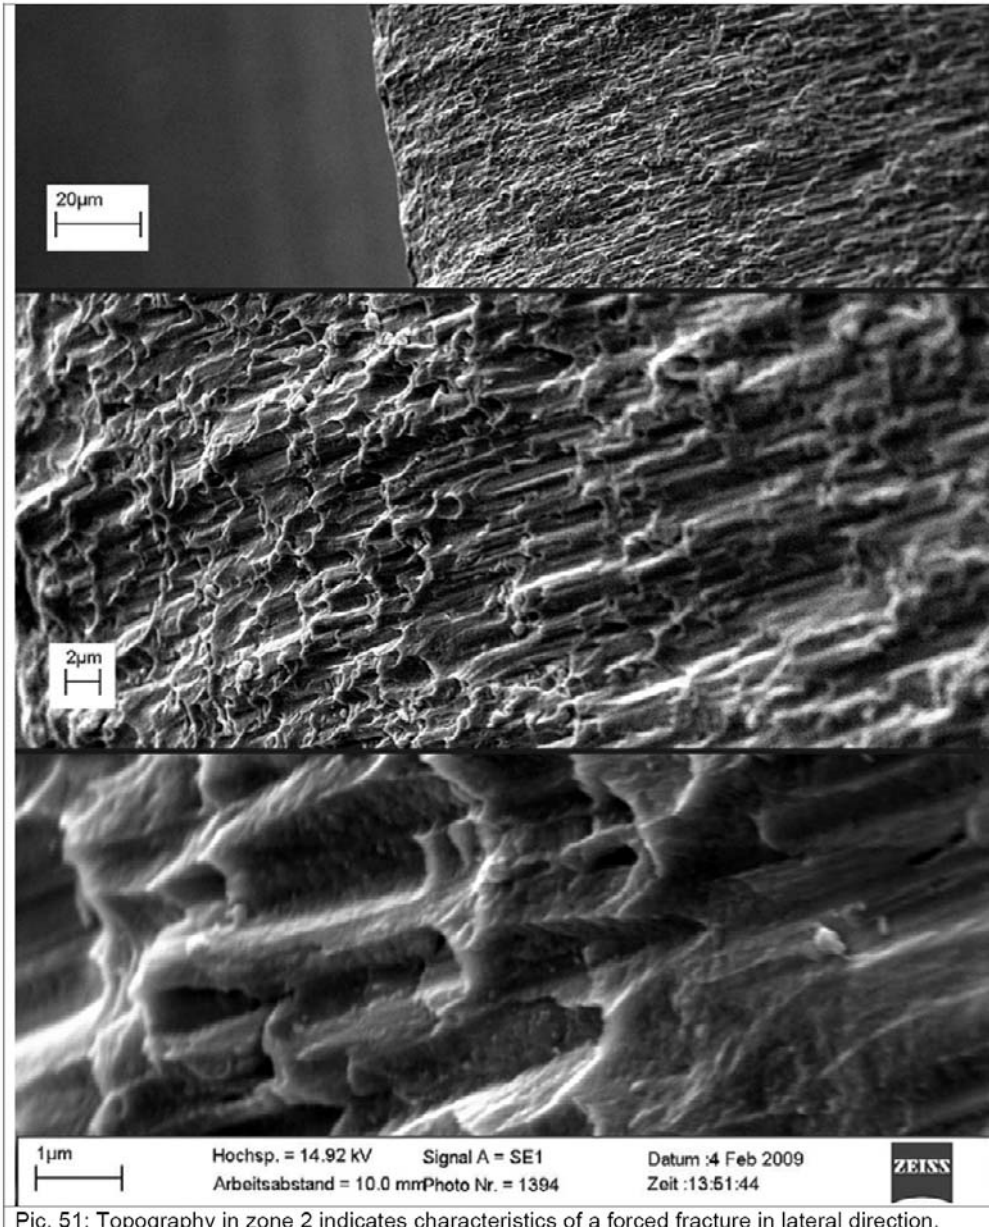
Pic. 51: Topography in zone 2 indicates characteristics of a forced fracture in lateral direction.

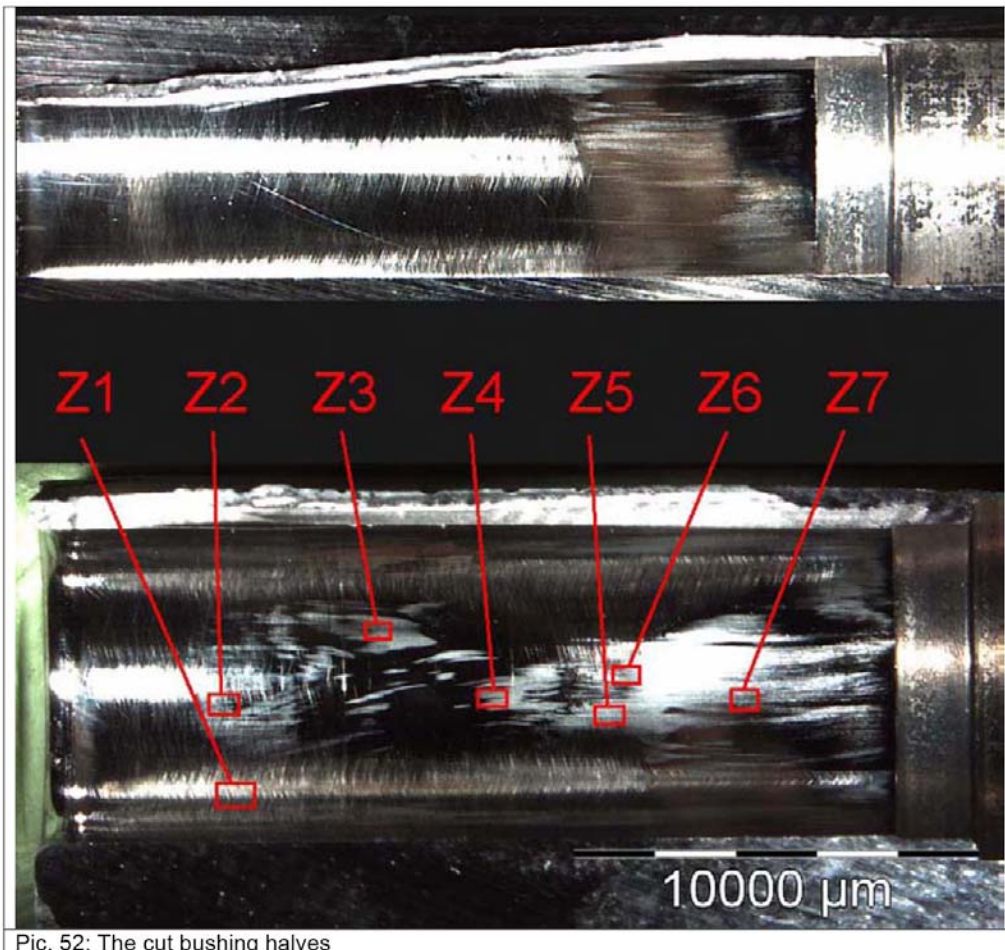
Pic. 52: The cut bushing halves

The bushing surfaces show signs of wear and annealing colors. The annealing colors are present in the front section (marked Z7). In order to be able to assign the following SEM micrographs, zones 1 to 7 were highlighted as reference points.

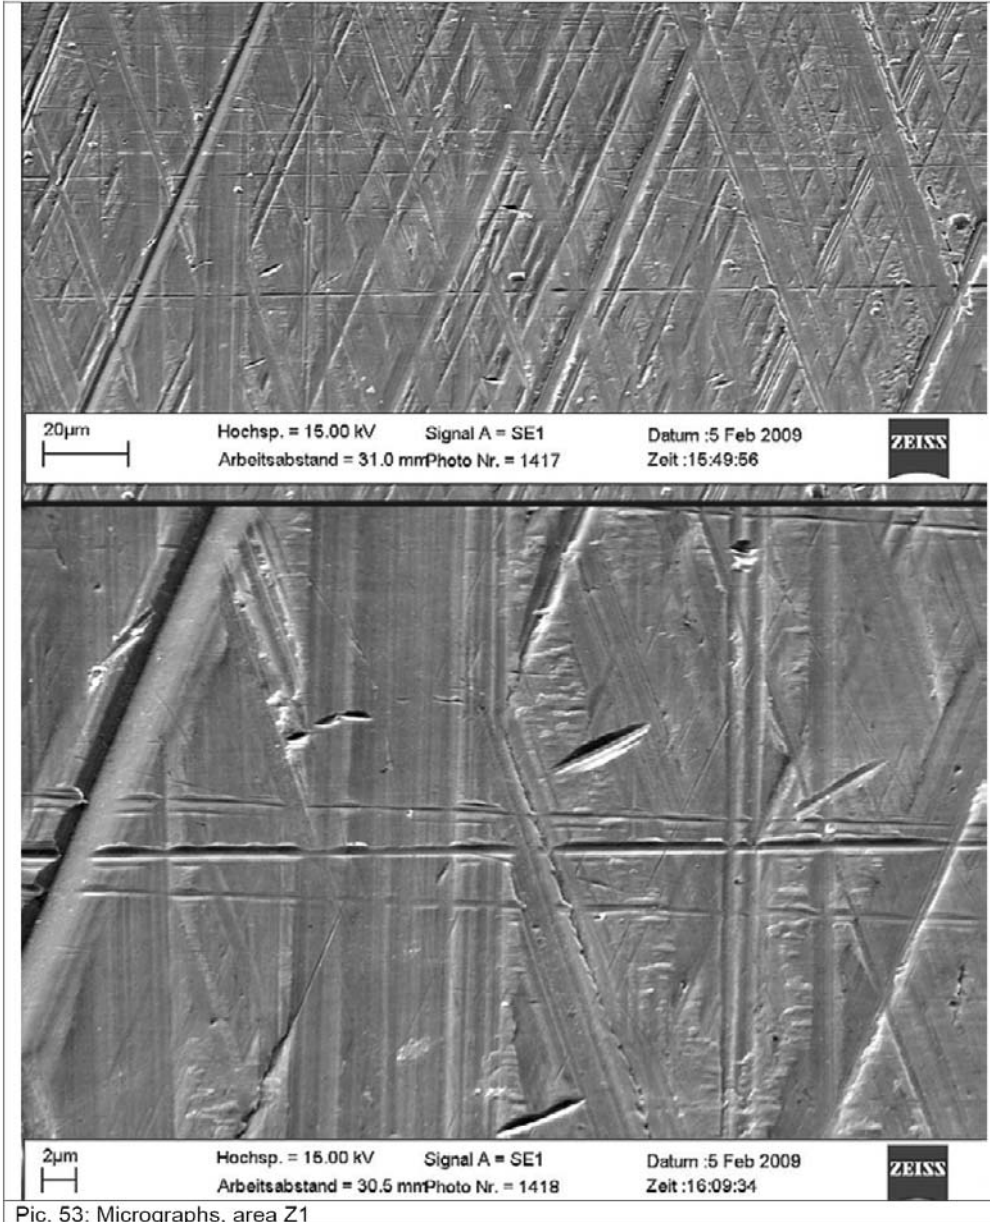
Pic. 53: Micrographs, area Z1

The micrographs above show area Z1, which shows normal wear and tear. The traces of honing (diagonal) and traces originated from grinding (vertical) are still visible. There are sporadic signs of abrasion through single particles present.

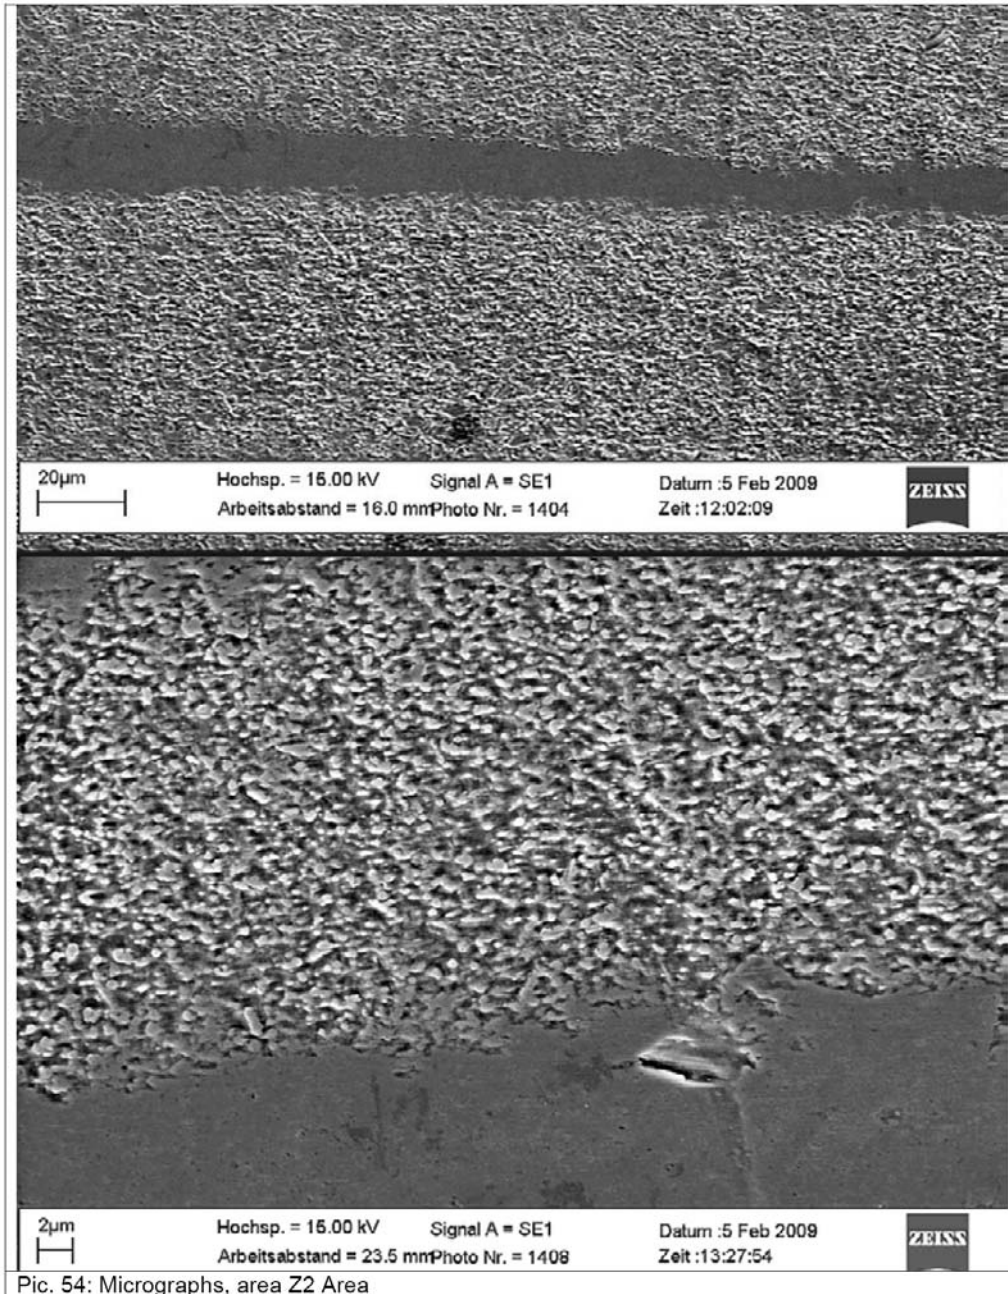
The area Z2 shows traces of adhesive wear, which is a kind of fretting

The adhesive wear identified in the SEM analyses, especially in areas Z2 to Z6, might be the result of micro welding joints.

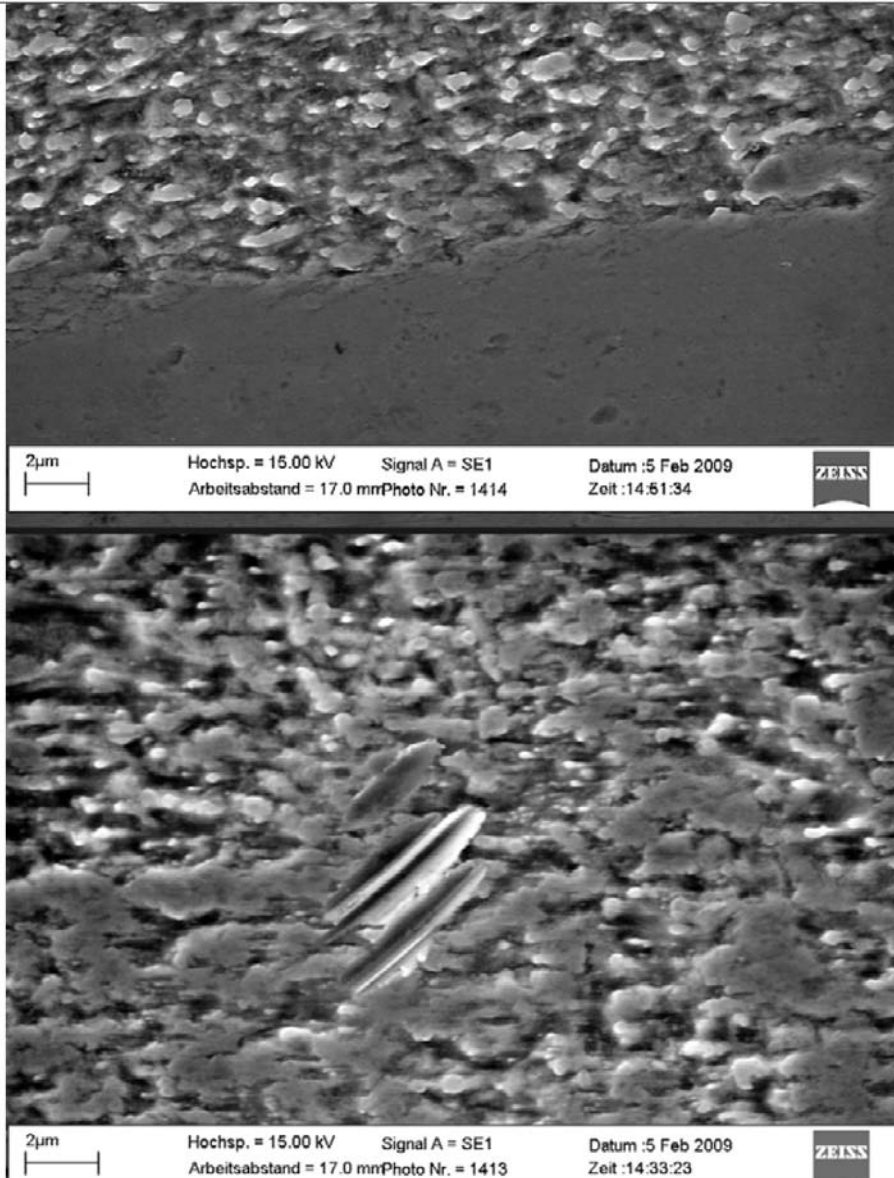
Pic. 55: Micrographs, area Z3

The area Z3 shows traces of adhesive wear. The lower micrograph shows abrasions caused by particles.

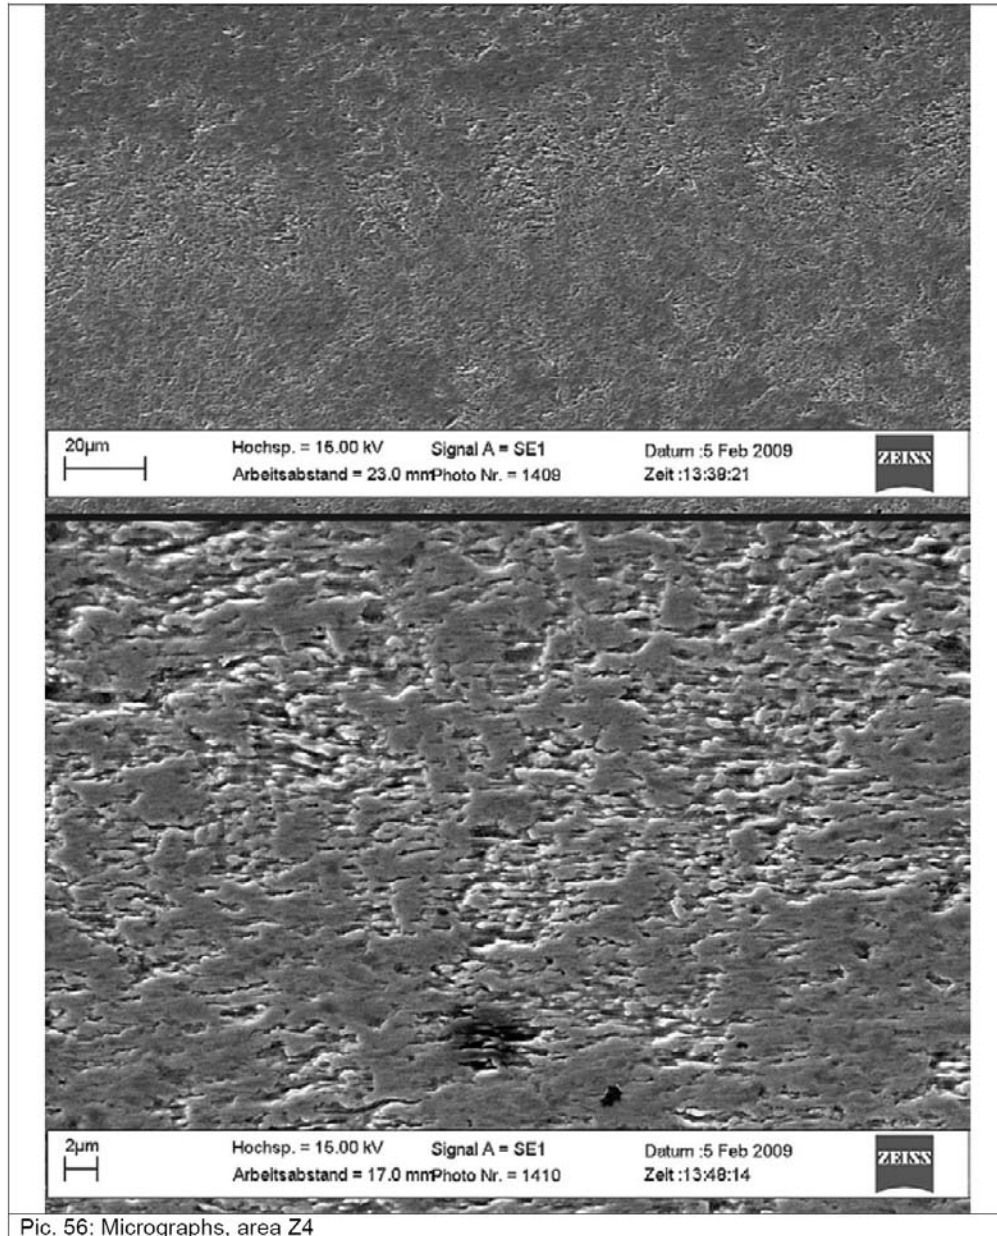
Pic. 56: Micrographs, area Z4

Area Z4 shows adhesive wear as well. It can be observed that micro particles were separated from the softer structural material, whereas the harder parts remained in place.
